# Performance of permeable surfaces

*Michael Borst, Chemical Engineer*

# The final design incorporates three permeable surfaces and unique monitoring capabilities.

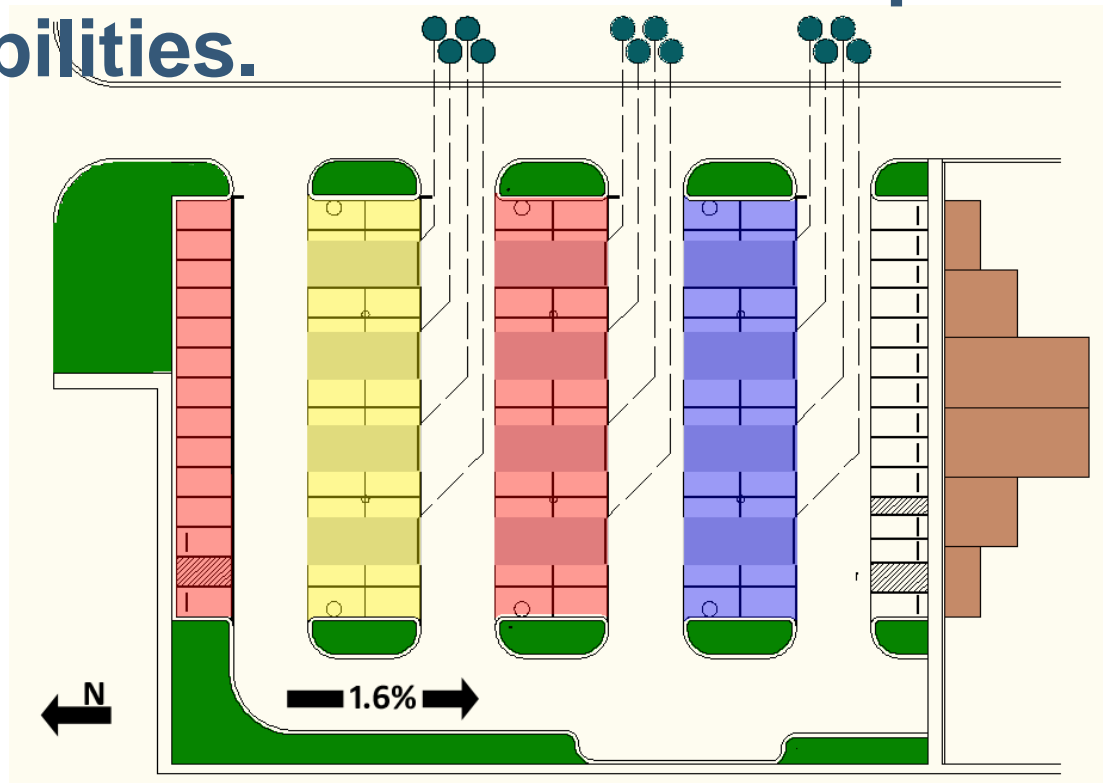
- Interlocking concrete pavers
- Porous concrete
- Porous asphalt
- Conventional asphalt
- Buried distribution pipes
- Collection tanks
- Rain gardens
- Tree islands

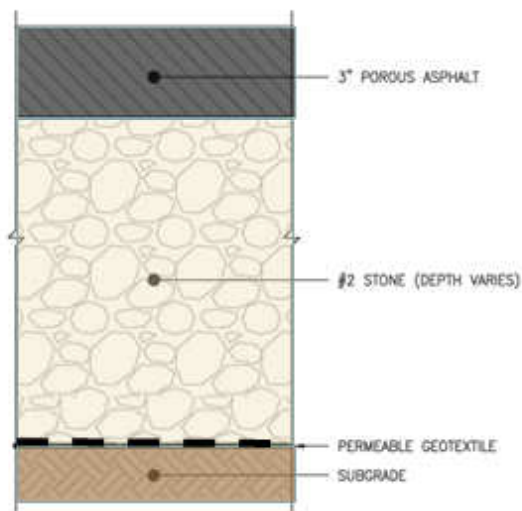
Porous  
Asphalt

# Vertical cross sections of permeable sections vary slightly from material to material

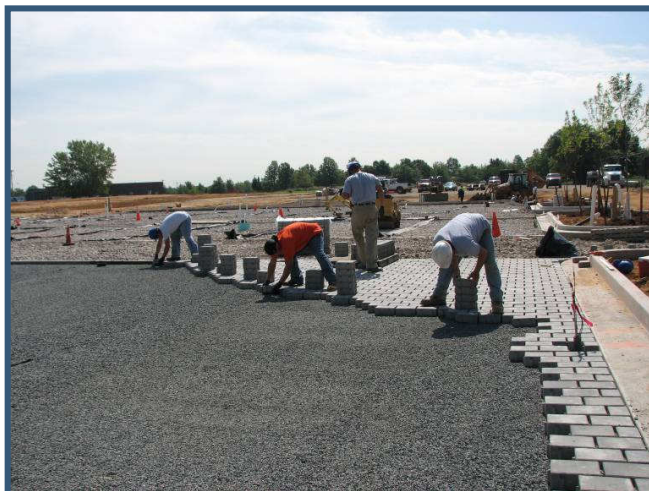
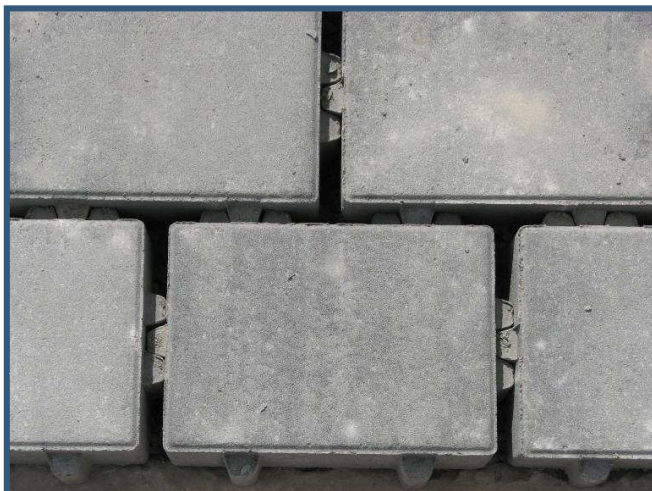
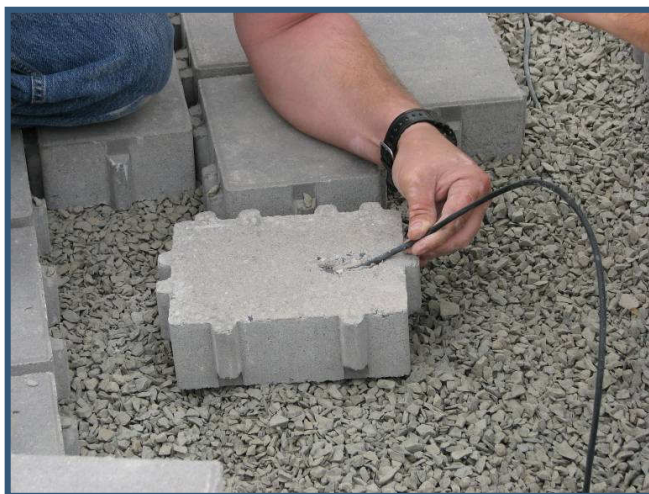
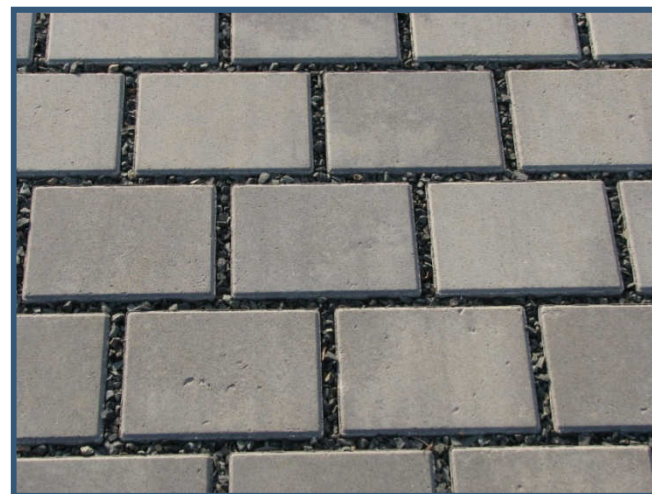
# Interlocking concrete paver installation took a little more than a week.

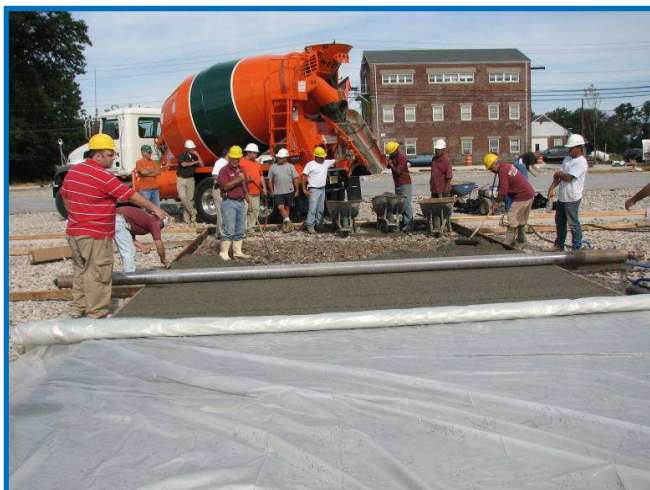
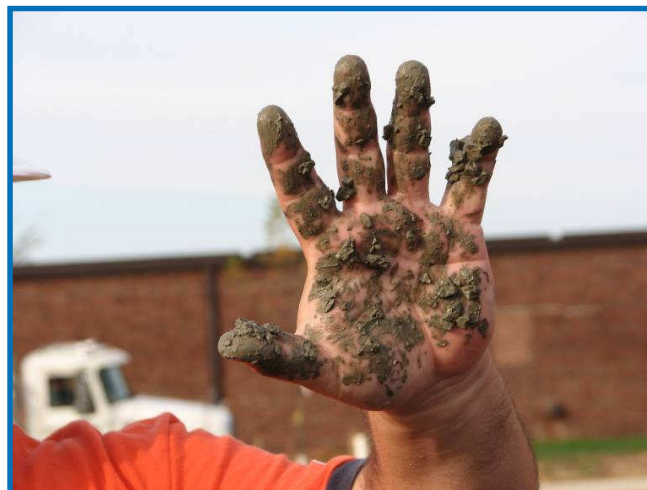
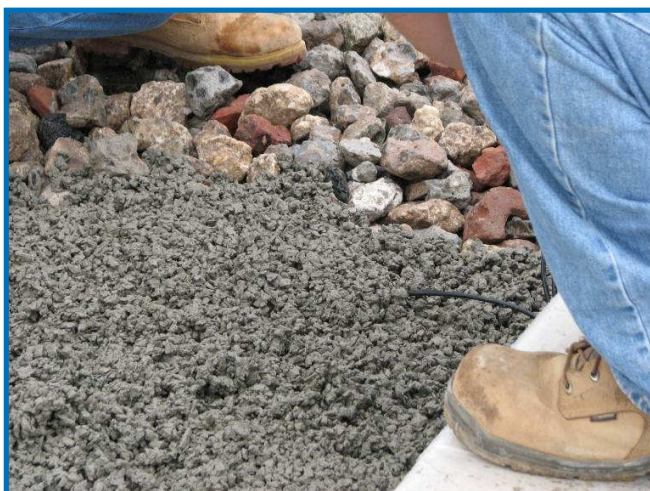
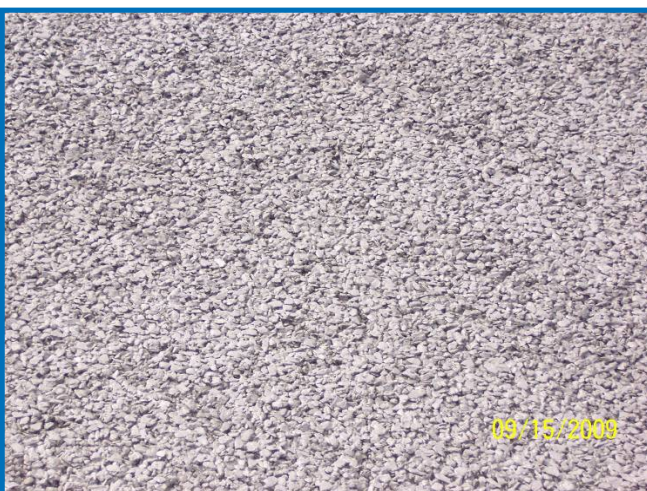
## Porous concrete pour took two days followed by a week of covered cure time.

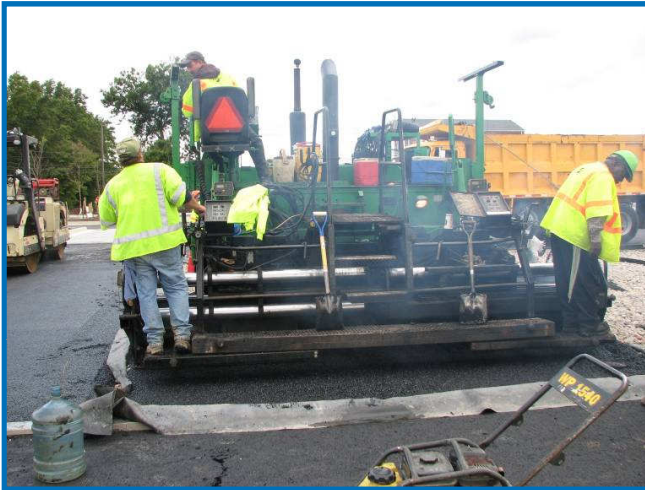
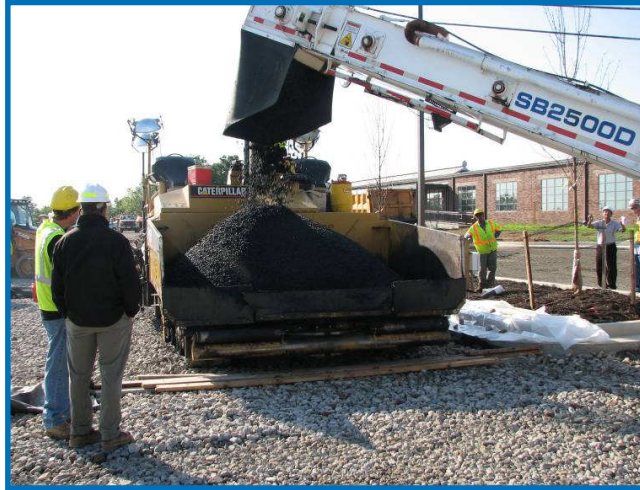
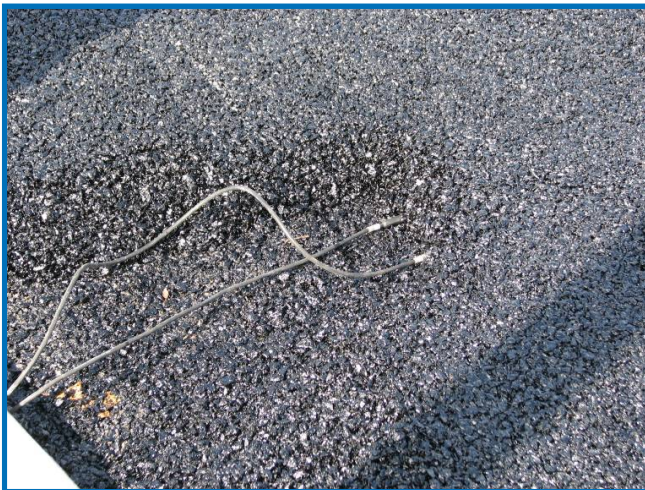
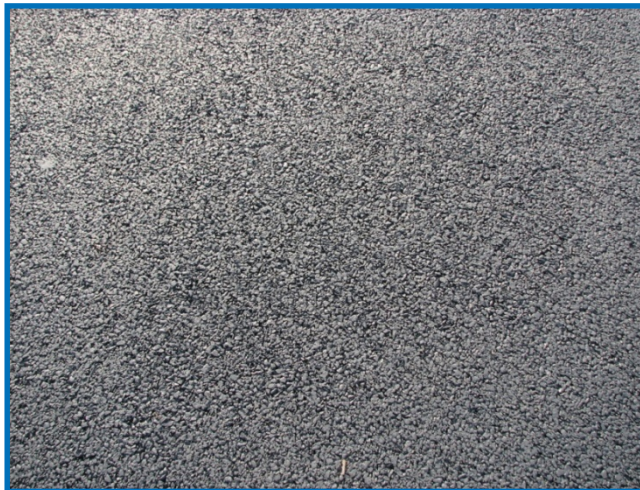
# Placing the porous asphalt took two days

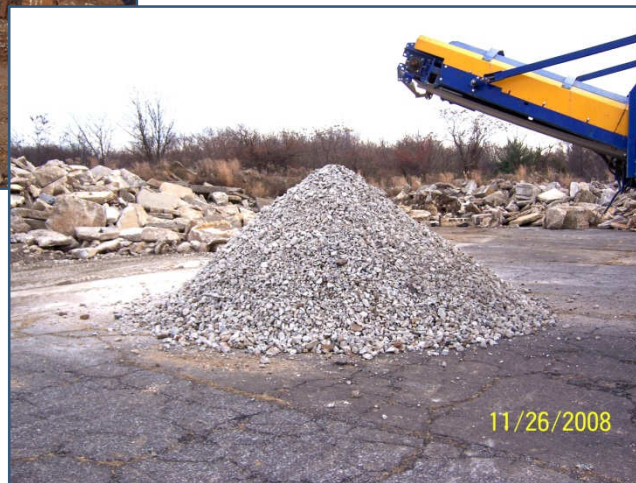
Crushing  
and  
screening  
to No. 2  
sized stone

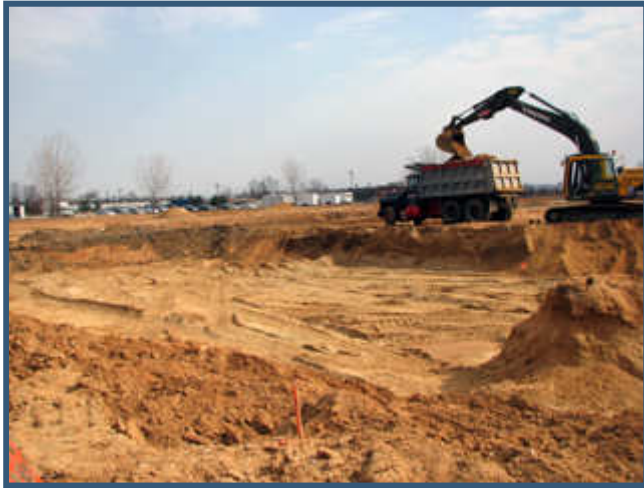
Excavating the storage volume.

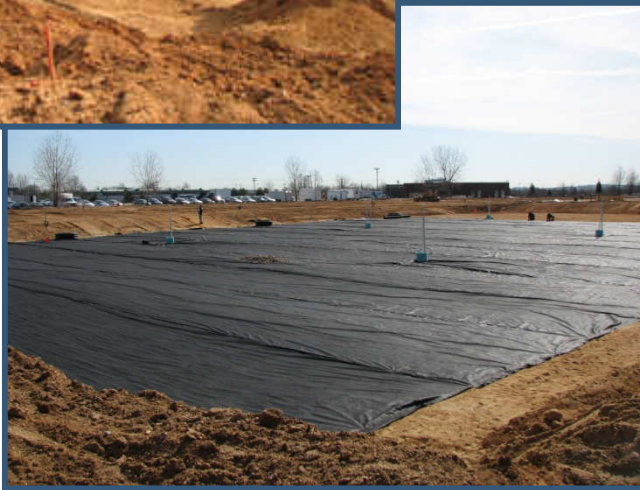
Geotextile placed at interface to underlying soil

#2 stone added from North to South and compacted with 20-ton non-vibratory roller.

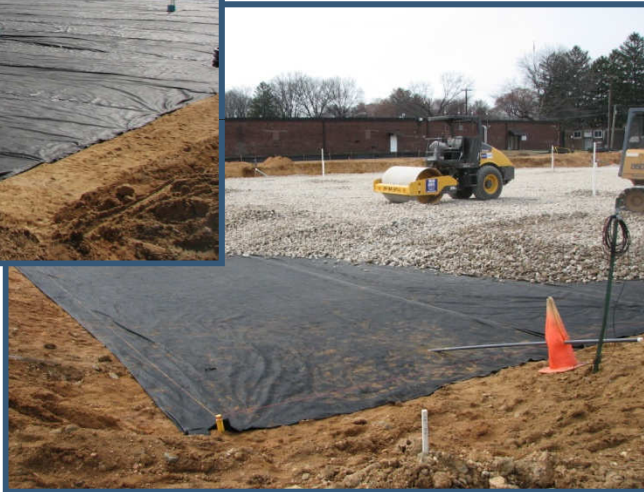
Asphalt and concrete placed directly on the #2 stone. Pavers required choking and bedding layers

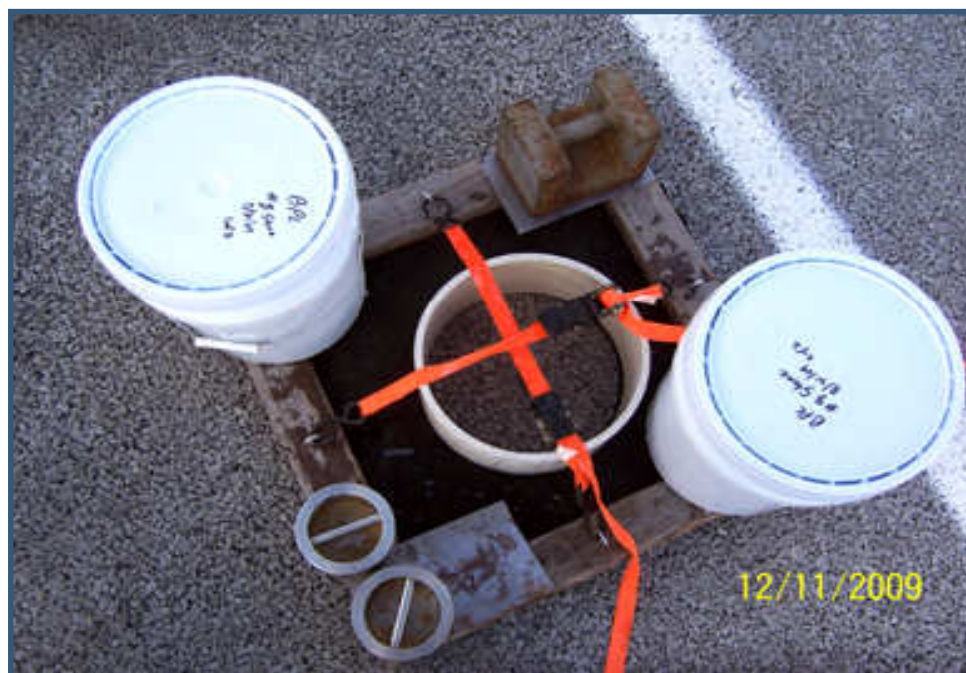
We measure infiltration rate at three randomly selected locations on each half of each surface monthly.

Modified ASTM C1701 apparatus

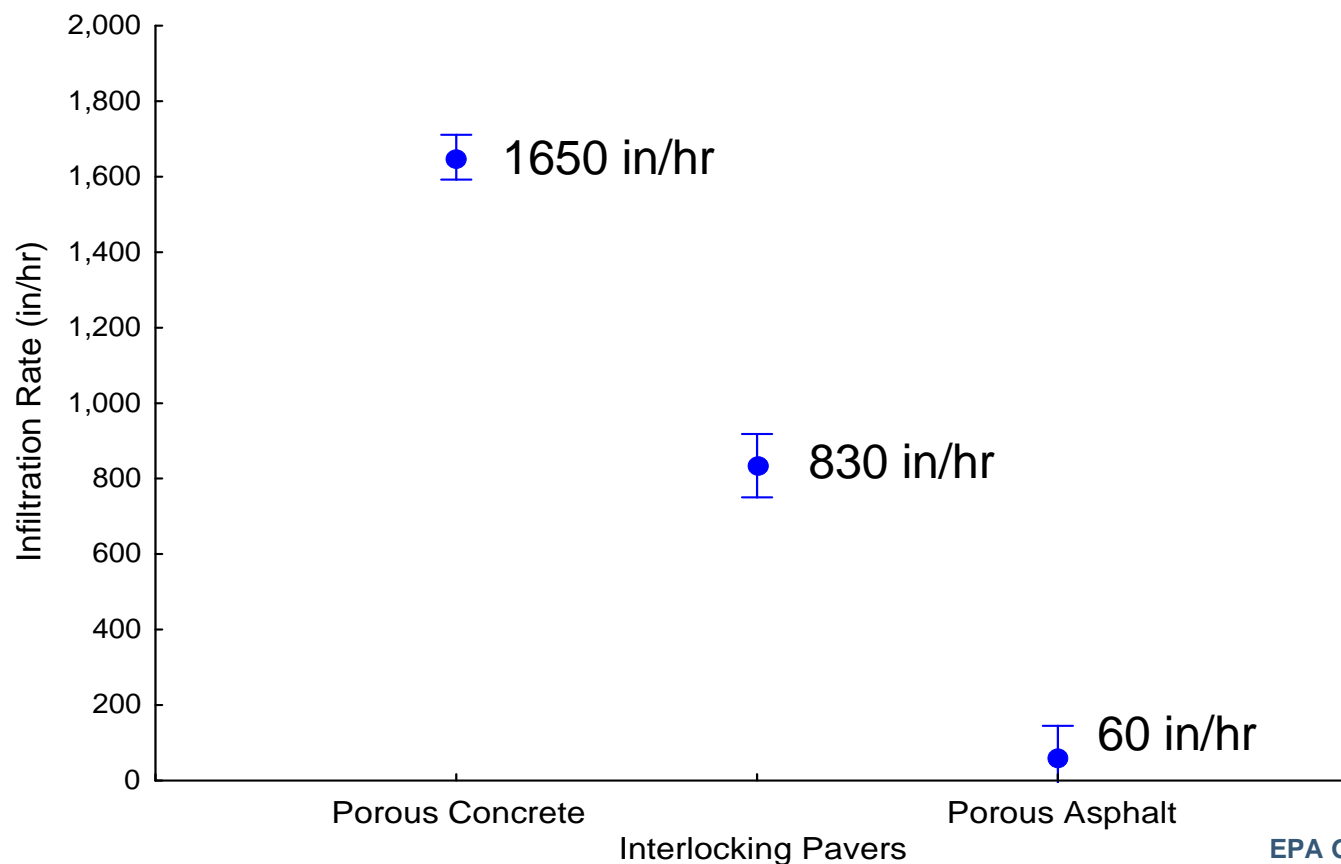
# The infiltration rate measured using modified ASTM C1701 varied across the surfaces

Current effect:  $F(2, 440)=478.87, p<0.0001$   
Vertical bars denote 0.95 confidence intervals

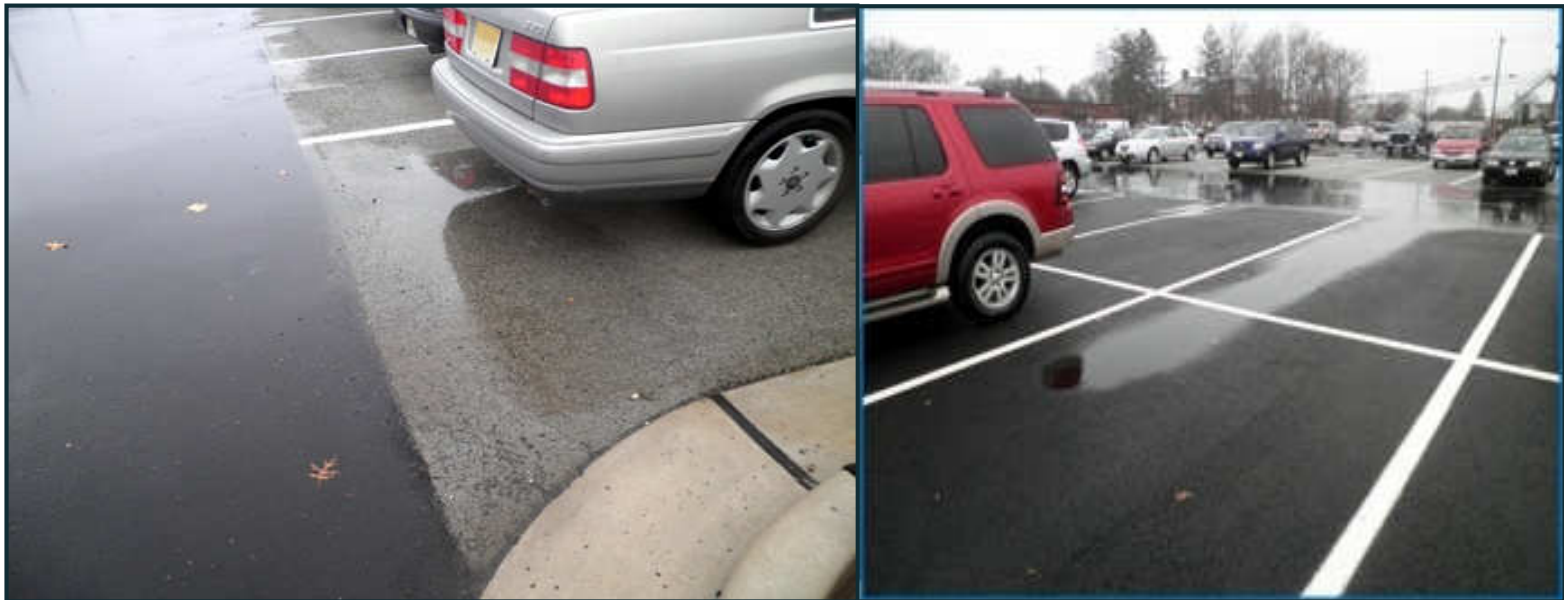
## The surface clogging does not result from uniform distribution of solids across the surface

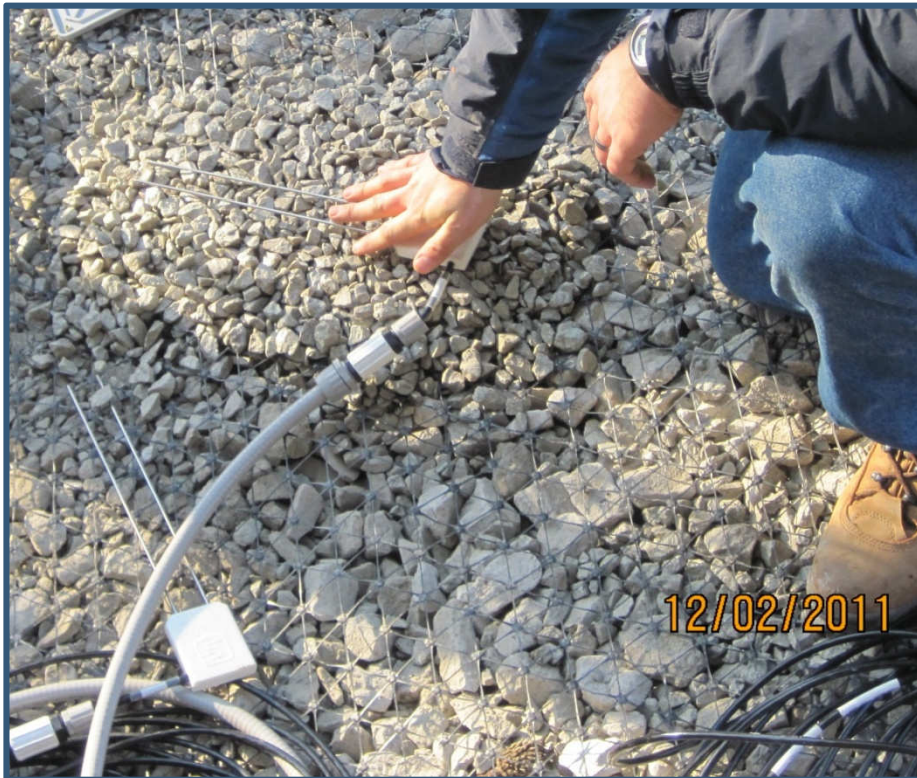
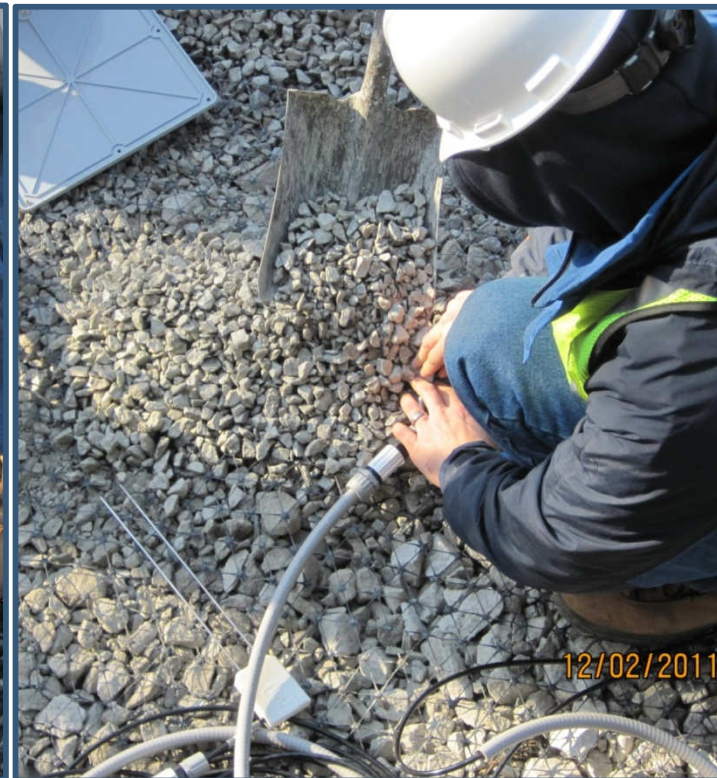
## Time Domain Reflectometers (TDRs) were developed to measure moisture under crops and turf grass to help assure efficient irrigation

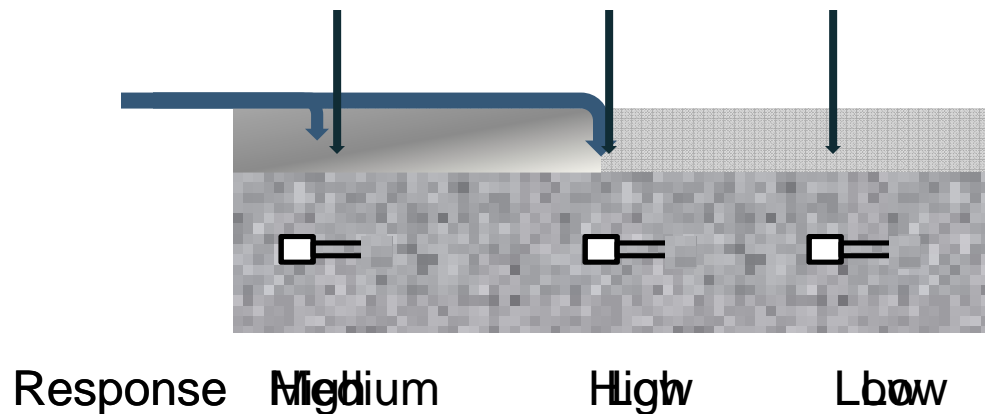
**We installed TDRs near the surface at locations to indicate if surface clogging was occurring and to measure its progression**

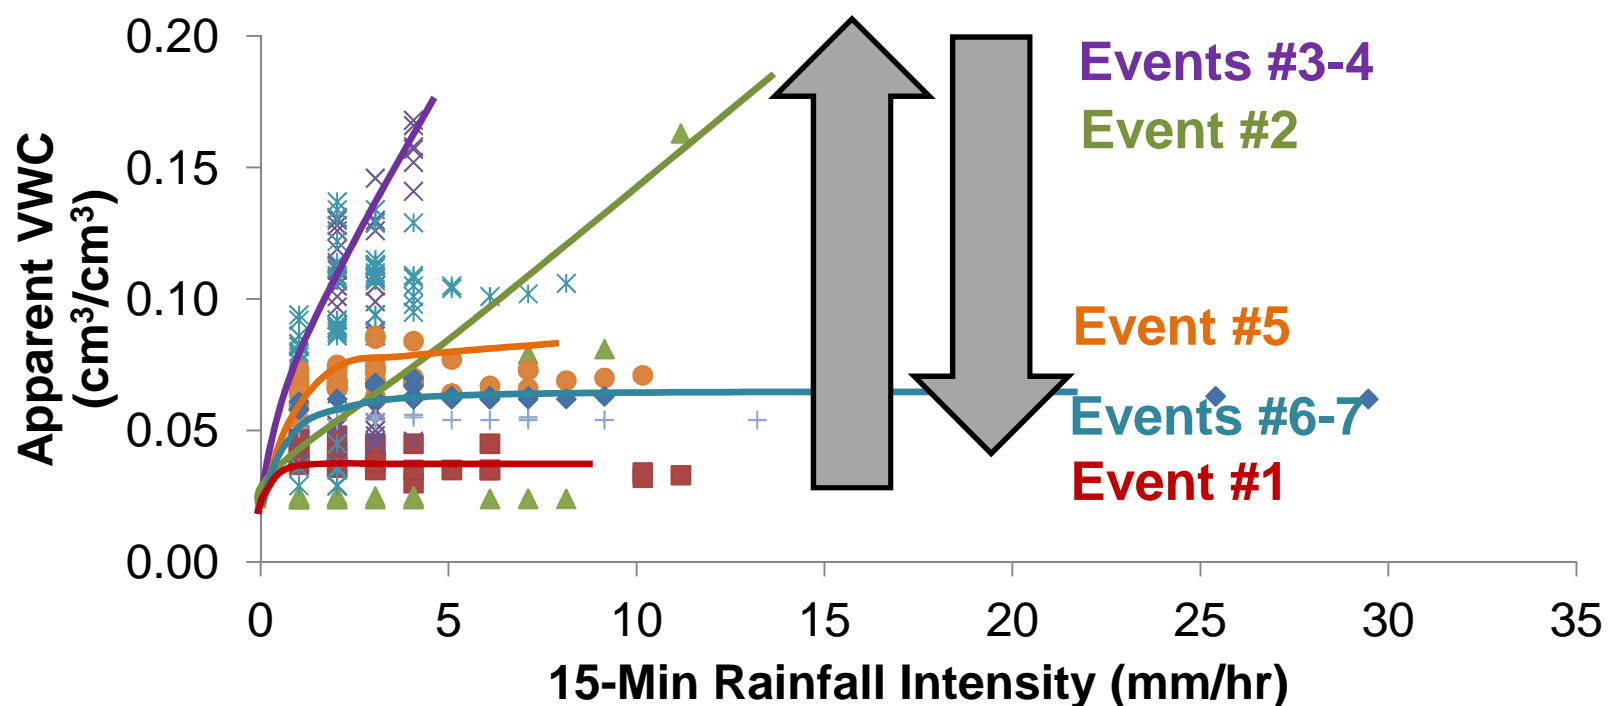
## TDR Response to the varying rain intensity can be used to measure and track surface clogging.

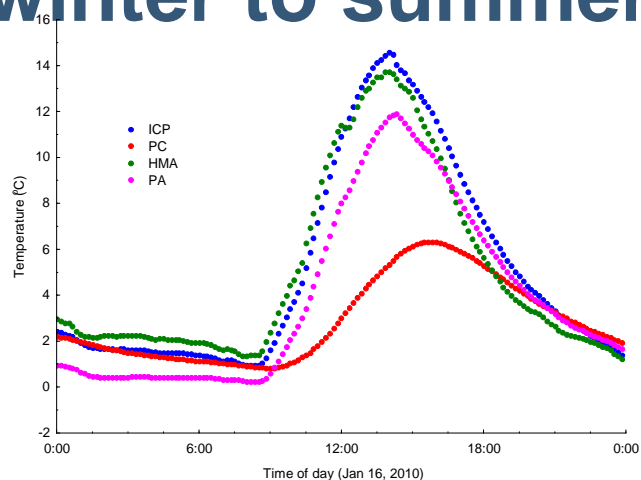
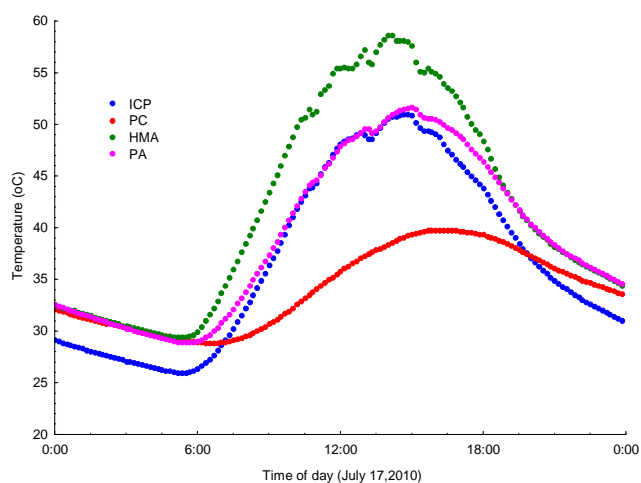
## Daily patterns show some differences winter to summer.

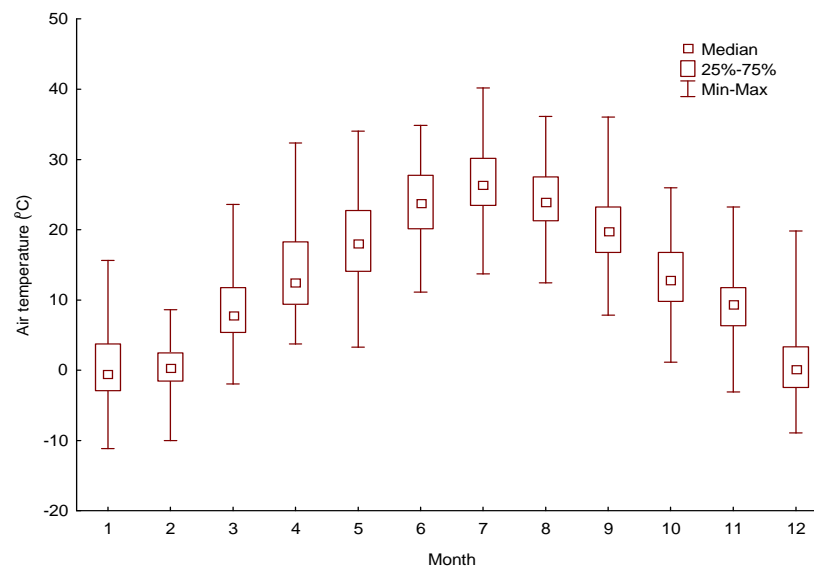
Minimal cloud cover days from incident light measures

Porous concrete has largest lows and it reaches its maximum and minimum temperatures latest in the day

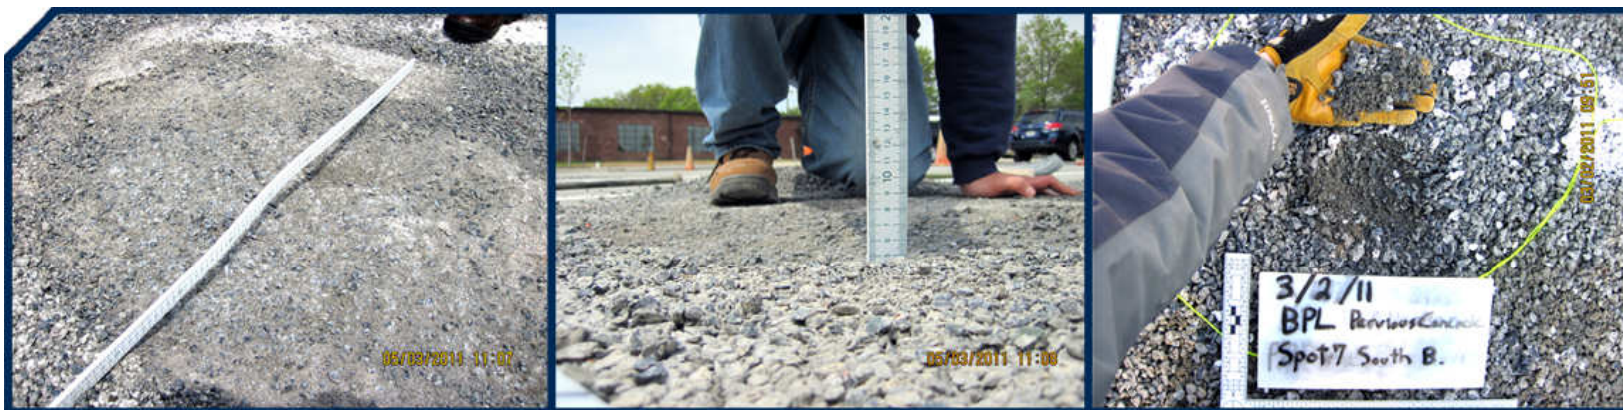
## A few places in the porous concrete disaggregated.

Roughly 28 inch across

Roughly 3 inch deep

Total less than 5% of area covered by porous concrete.  
Suspect dirty aggregate prevented good concrete bonding.  
Became apparent about 18 months after pouring concrete.

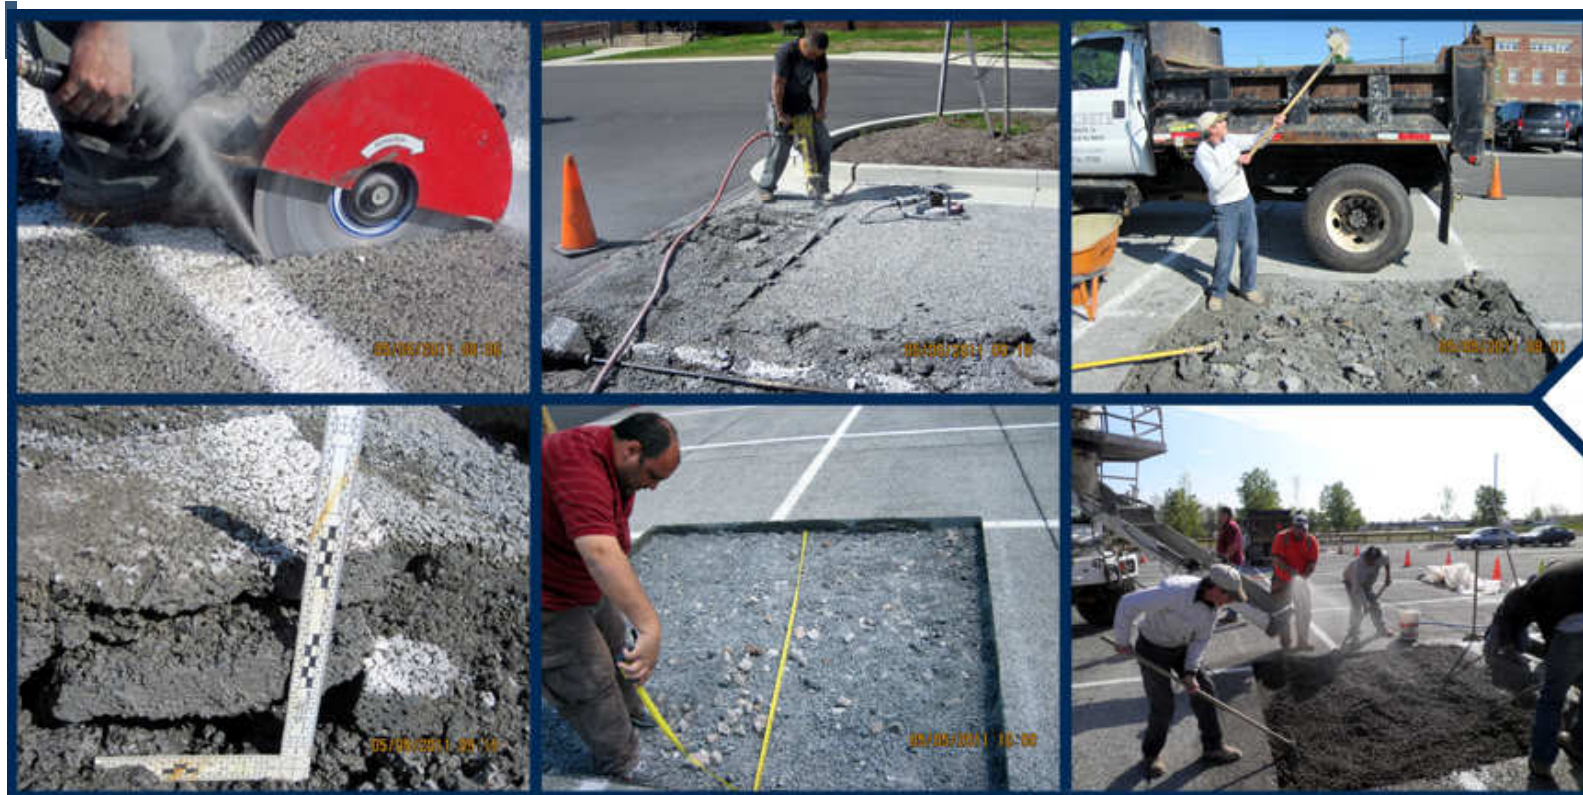
## Destructive investigation showed the failed sections had formed separate

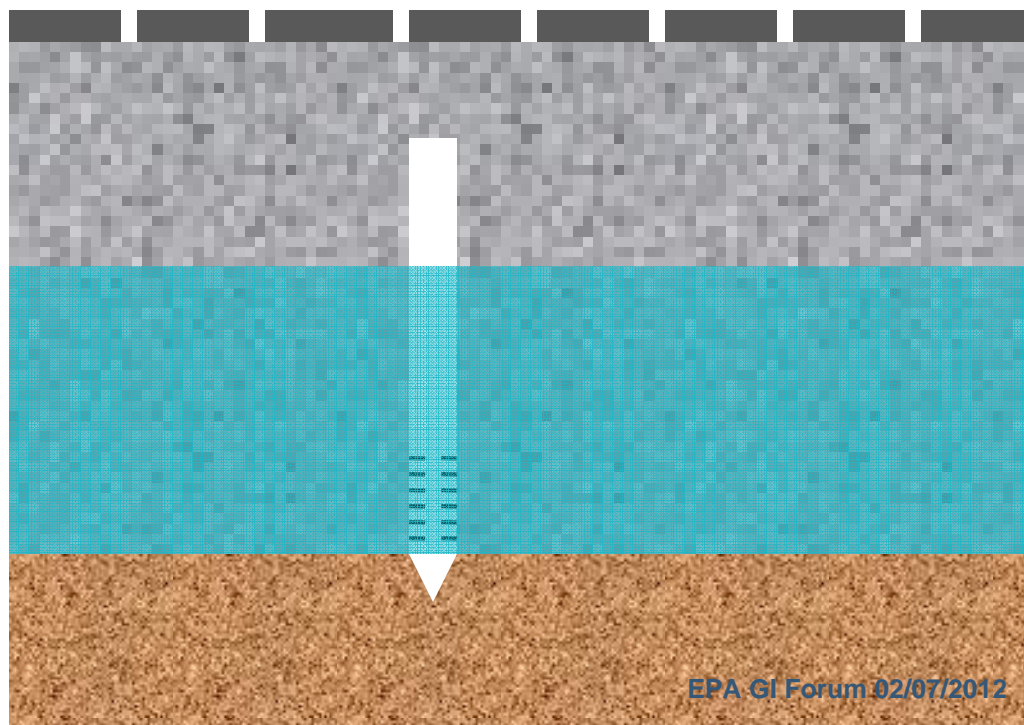
## We installed the pressure transducers in the piezometers to measure the accumulation and infiltration (rise and fall) of captured water

The fill rate is controlled by rainfall intensity while drain is controlled by saturated infiltration rate.

Depth (volume) is controlled by depth of rainfall, dimension, porosity and infiltration during event.

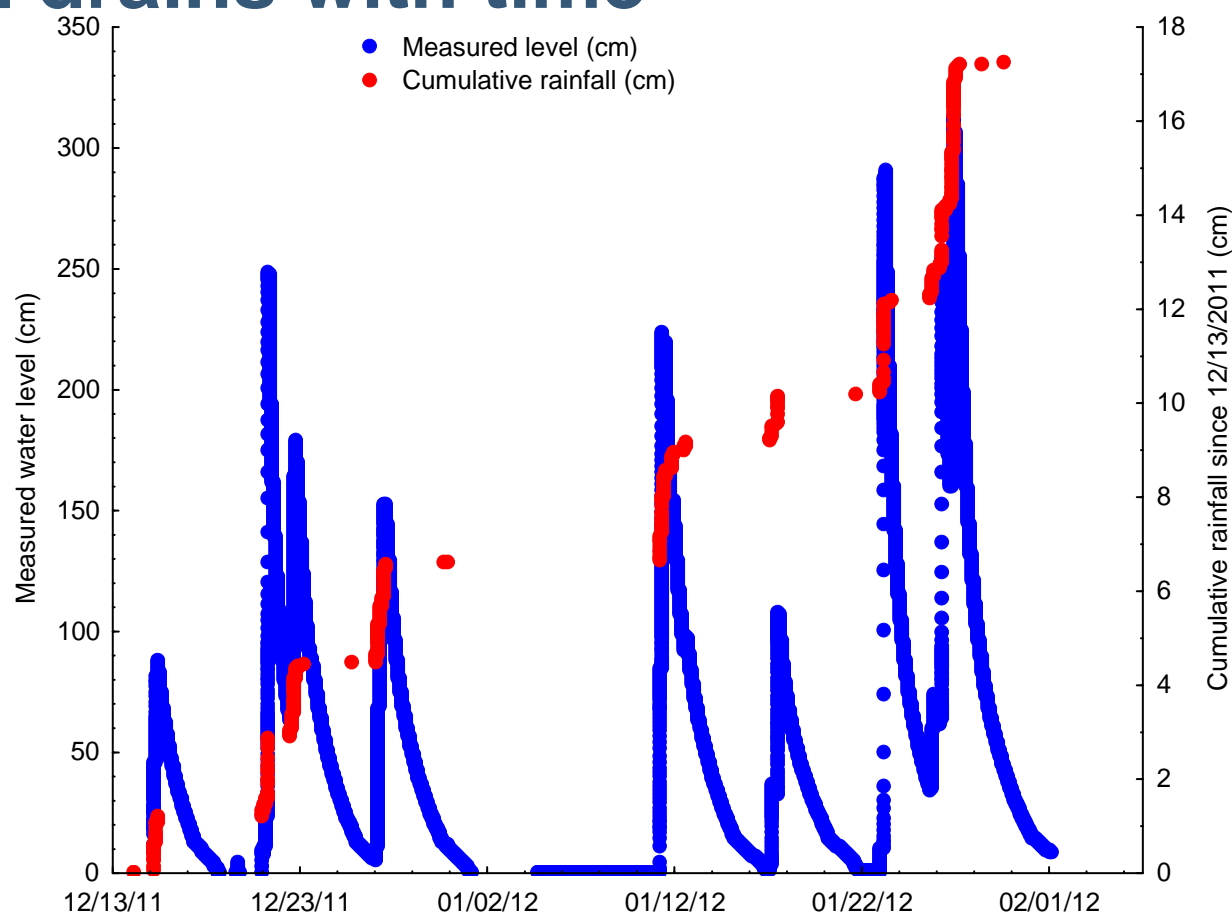
## The water level in the control rises with rainfall and drains with time
